Wire Coiler Improvement

David MarcAurele, Jason Ringer, Drew Straub, and Brian Harper
Team #7

MET 494 Senior Design & Analysis, Spring 2017
April 24, 2017

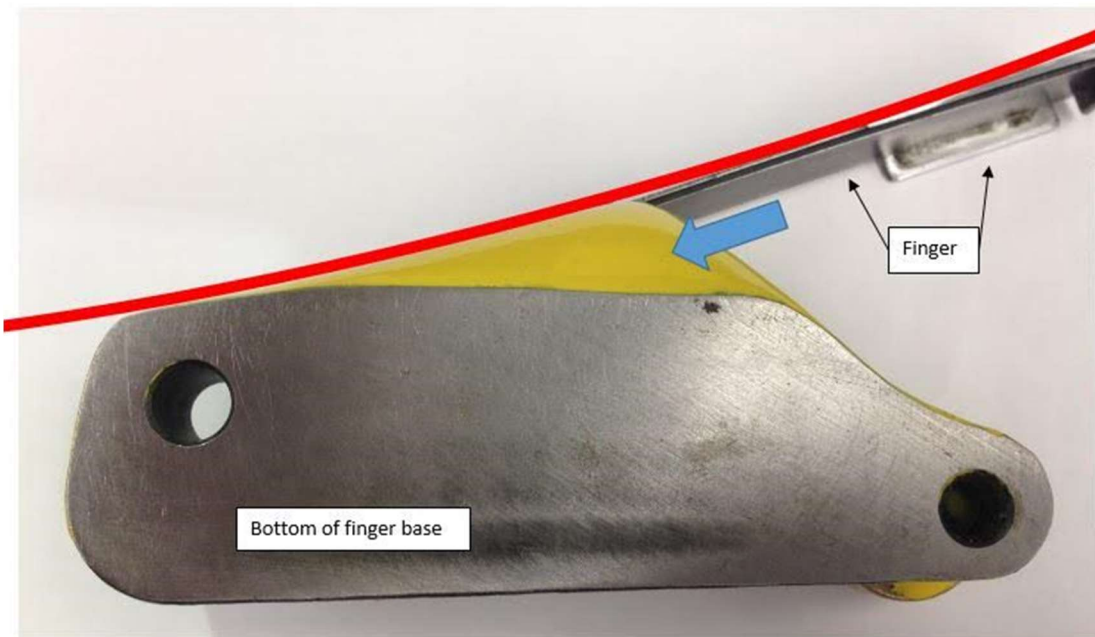
It was decided that the base of the finger mount would be painted yellow, which was done for two purposes. The first purpose was to provide a temporary fix to the problem while the team worked on a permanent solution. The paint provided a softer impact surface, which helps to reduce the damage done to the wire when exiting the coiling machine. The second purpose was to provide an accurate visual representation of the impacts occurring during operation. Since the paint eventually wears off over time due to the repetitive impacts, the bare metal underneath appears exactly where the impacts are located. Shown on the next two pages is a detailed assembly drawing that depicts the stationary portion of the coiling mechanism, two pictures that provide a close-up view of a finger and its base, and a picture that shows the impact locations on the base of one of the finger mounts.

Figure 2. A close-up view of an individual finger and finger base with the yellow paint added.

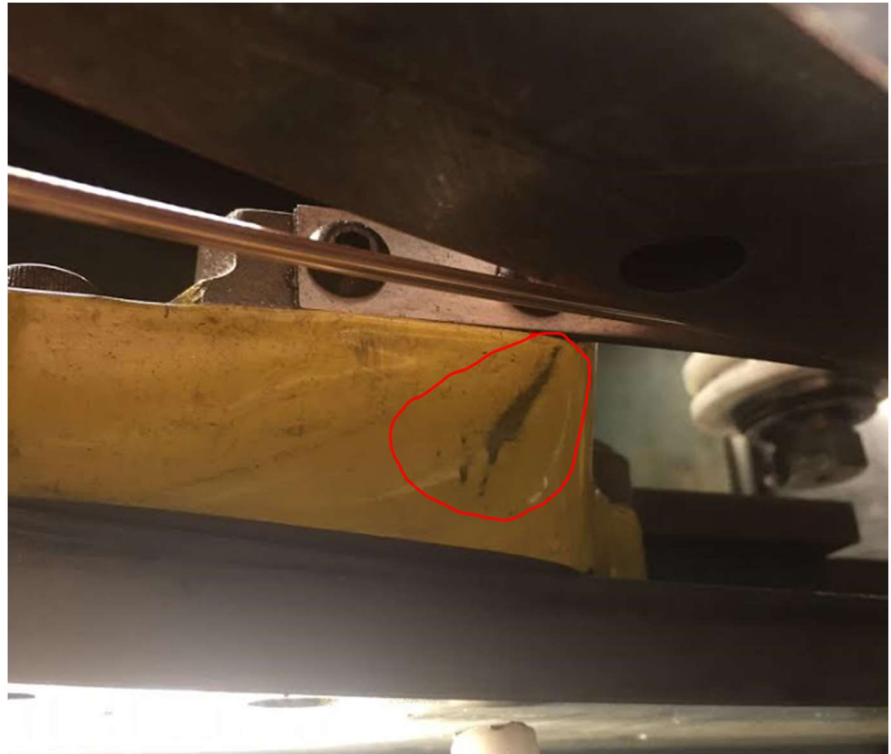
As stated in the official proposal for the project, the coiled copper wire has a tendency to spring outward once release from the coiling machine. In turn, this causes the wire to make momentary contact with the base of each of the 15 fingers mounted to the machine. The fingers help to keep the coiled wire's shape by pressing the wire against the rotating portion of the coiling mechanism and consist of two flat, rectangular plates of steel. The front plate is the plate that makes contact with the wire and is made from a polished chrome steel. The back plate is mounted behind the chrome plate, which provides extra support and is made of plain carbon steel. The impacts made by the wire to each of the 15 finger bases results in minor defects of the wire's surface; an issue that can affect the quality of the final product. Though it was known that contact with the base was being made, it was not known where the exact point of contact was. In order to better understand the problem, a simple solution was proposed.

Figure 4. An image showing the exact contact location between the coiled wire and the finger base.

After determining the location of the impacts made between the wire and finger base, the team set out to come up with solutions that would resolve this problem. The initial suggestion was to replace the face of the base on the existing part with another material that would take the blow of the wire, as it hit the part, without damaging the wire. The materials considered to make up the insert were ceramic, plastic and rubber, with ceramic being the most compelling because of its ability to be ultra-durable and smooth and the fact that the light force of the wire hitting ceramic would not be enough to damage the ceramic itself. Ultimately though, the team decided to redesign the base of the finger by recessing the portion of the base of the finger that faced inward to the machine completely in order to provide complete clearance between the base and the wire exiting the coiling mechanism, with the hope that doing so would eliminate the chance of impact. The second solution was to be redesign the supporting back-plate of the finger. Extending the width of this plate would result in a greater guiding assistance of the exiting wire to the bin below the machine. The team believed that the combination of these two modifications would prove to resolve the problem.

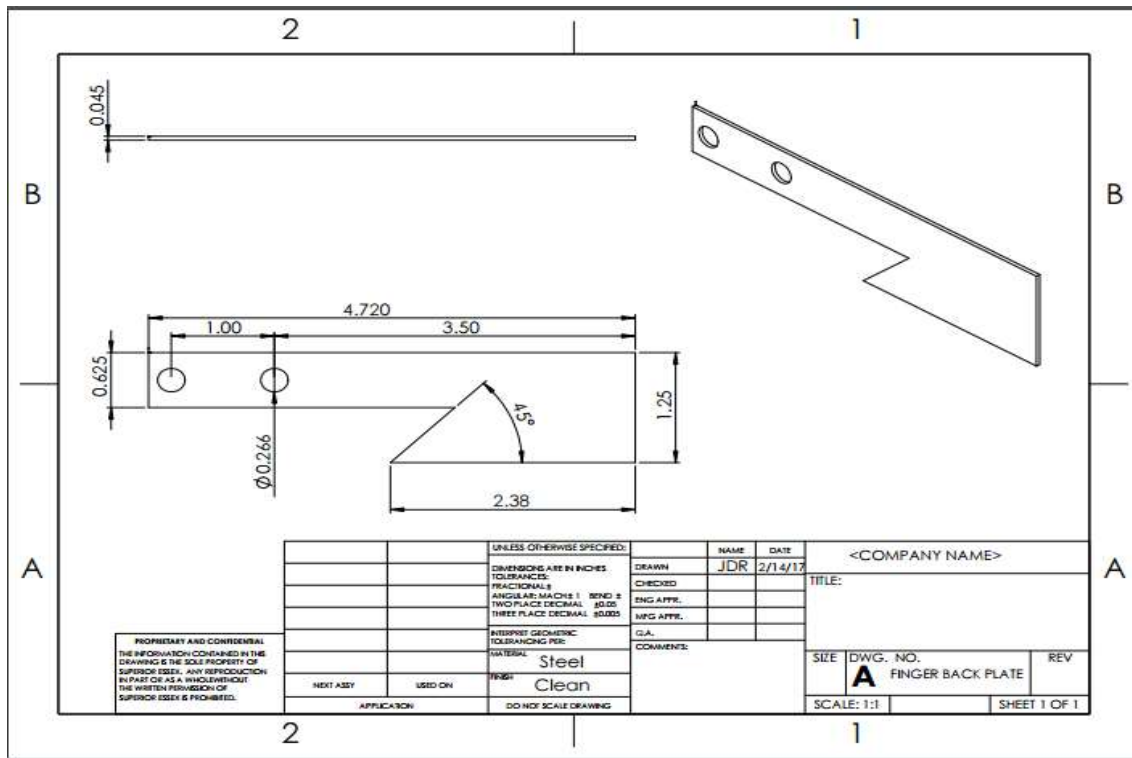
Figure 12. Proposed back-plate redesign. Note the extended width to provide guidance of the wire to the bin below the machine. The portion of the plate with the 45-degree cut will be bent back slightly (into the paper) to smoothly guide the oncoming wire to the main portion of the plate.

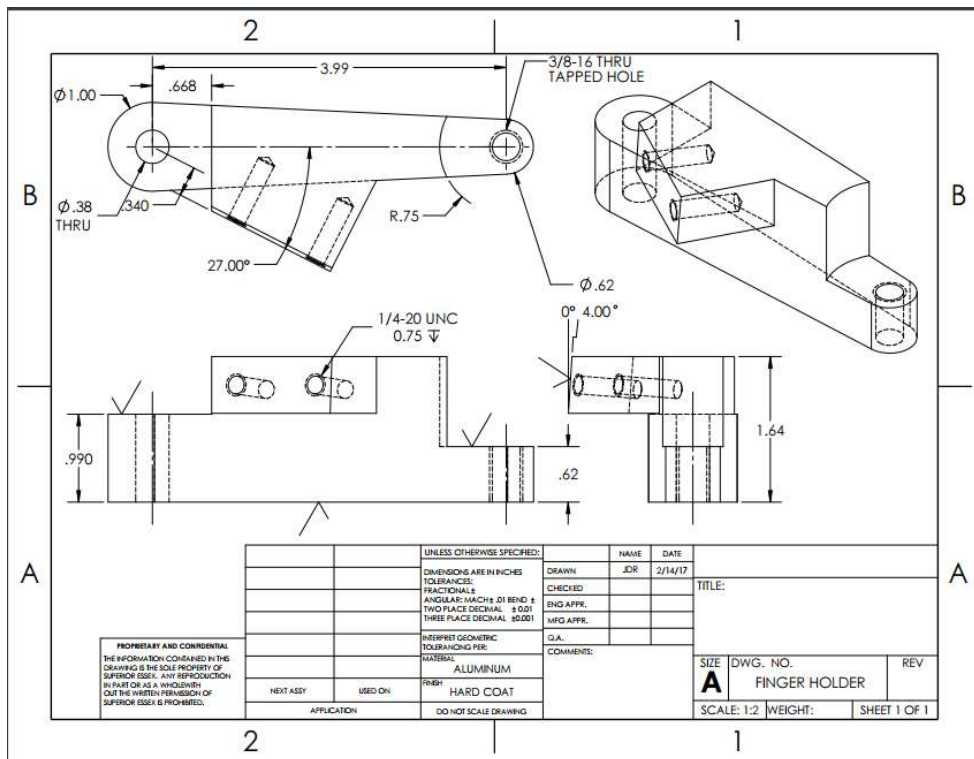
Figure 14. A completed CAD drawing of the initial proposed finger base. Note the removal of the lower portion of the original base, which was painted yellow. This undercut provides additional clearance between the wire and the base.

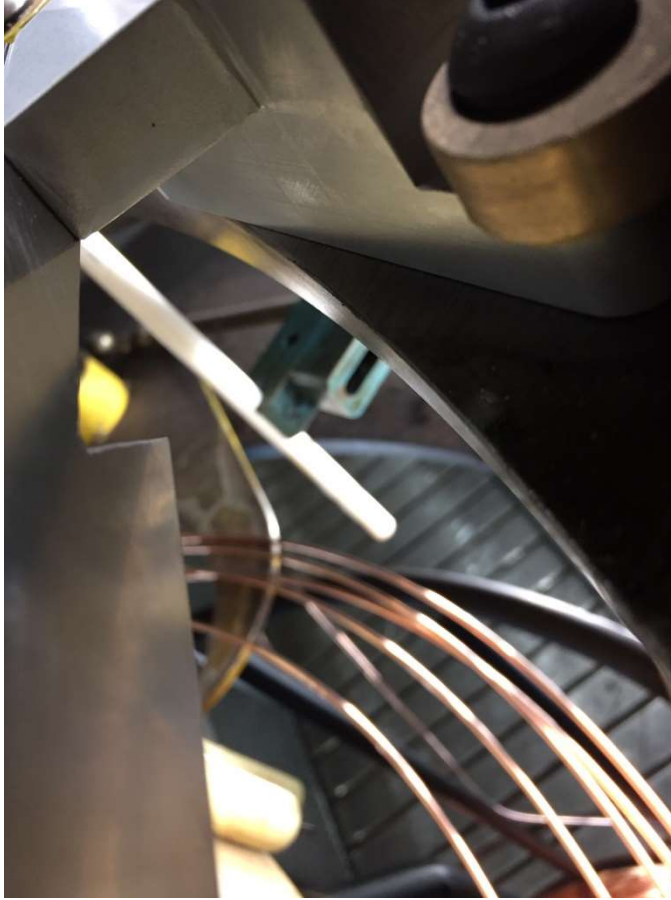
Figure 17. A close-up view of the underside of the new finger base showing the additional clearance provided by the undercut.

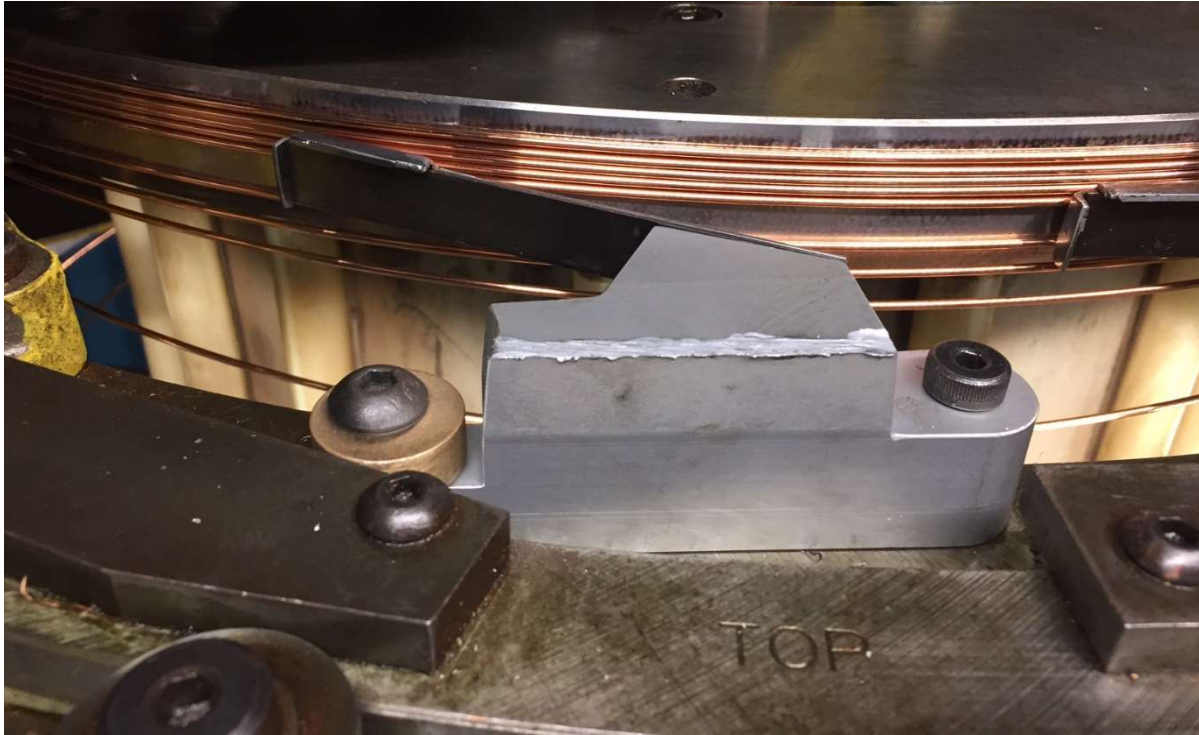
After the test fitting of the new components, the first testing procedure began. Right away, unfortunately, there was a problem. After the machine was started, the operator heard thumping noises coming from the machine. The machine was then inspected after being shut down to search for the source of the noise.

It was determined that part of the radial arm for the coiling mechanism was making contact with the top rear portion of the new finger base. Each pass of the radial arm scraped the new finger base, creating the repetitive thumping sound that the operator heard. To provide a temporary fix, the damaged surface of the finger base was sanded down in order for the radial arm to clear it when operating. The following pictures were taken after the discovering the damage done to the finger base.

Figure 18. A close-up view of the damage done to the finger base.

Following the issues of the first testing procedure, it is clear why the original finger bases were designed in such manner. The team made a small design change to the finger base to prevent the issue from occurring again. It was decided that the easiest change to make is to include a cut out of material to the top rear portion of the finger base.

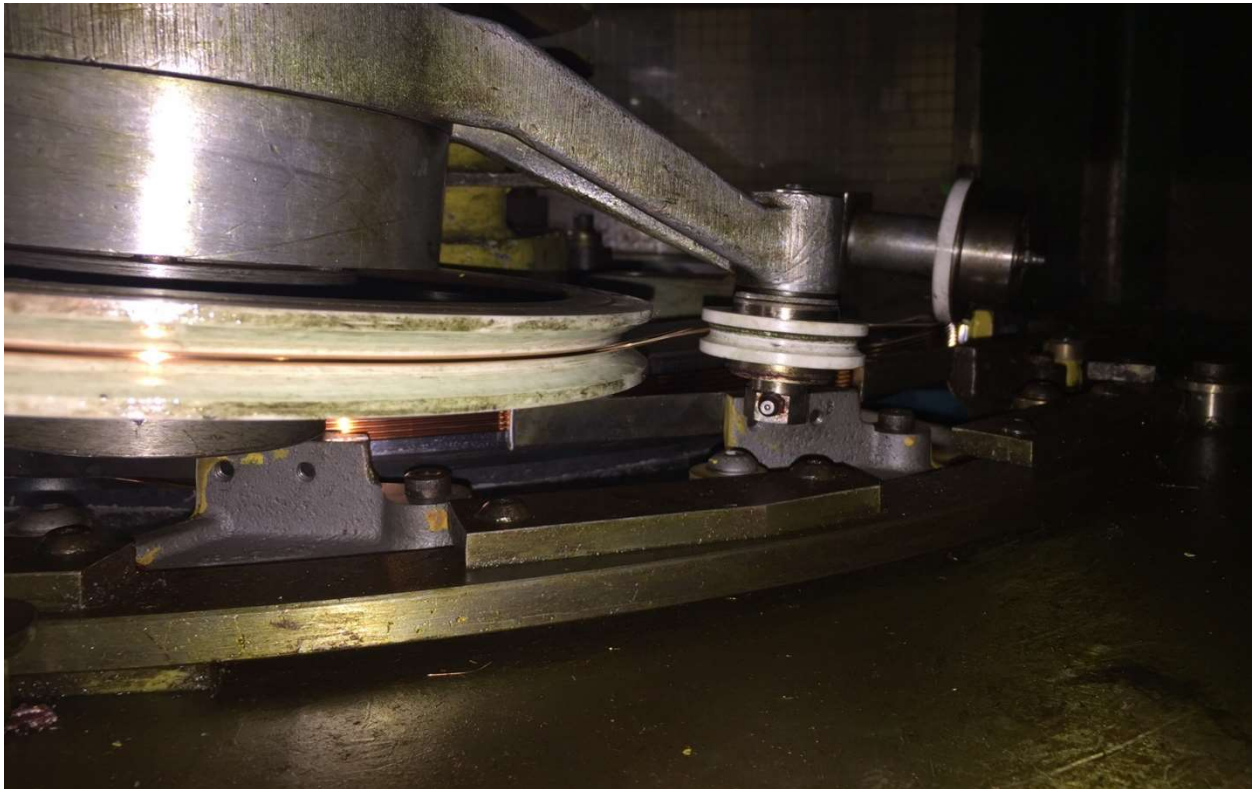
Figure 19. An image of the radial arm. The portion below the small white pulley is the cause of the damage to the finger base.

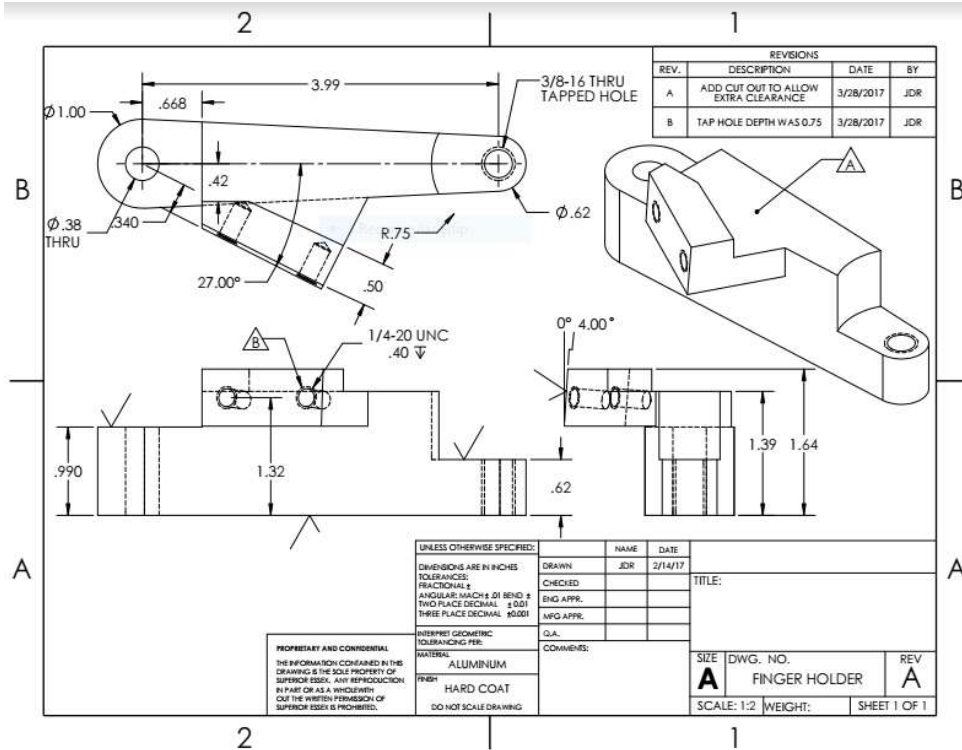
Figure 20. A completed CAD drawing of the improved finger base. Note the removal of the back of the base where contact was previously being made by the radial arm.

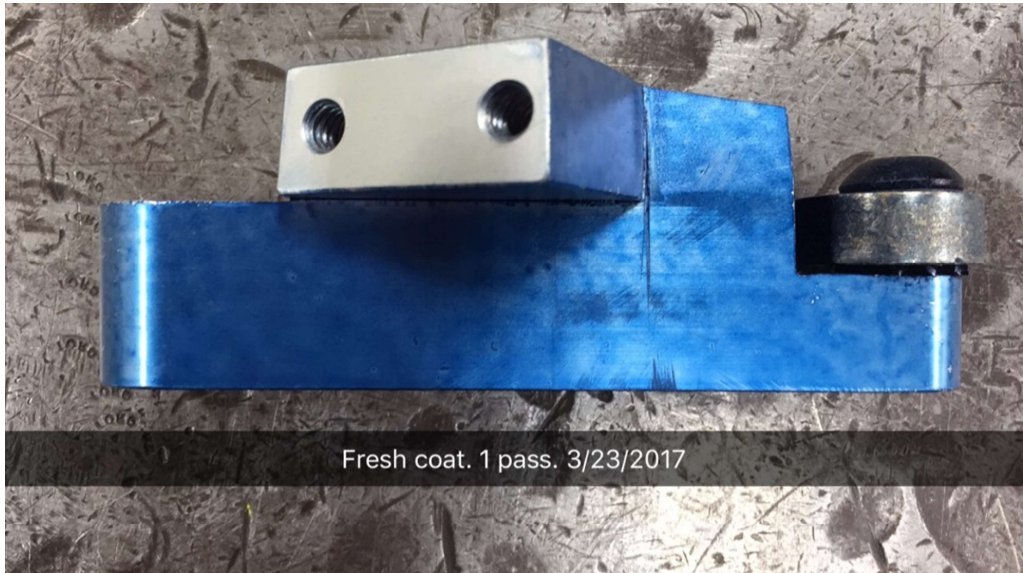
Along with the slow-motion film, the team sprayed the finger base and mounting ledge with layout fluid. The purpose of this was to provide additional confirmation of any improvements made by the new designs. The layout fluid acted like the yellow paint used initially in the project. If the copper wire was still making contact with the machine, bare spots in the layout fluid would have confirmed that.

Figure 23. A view of the improved finger with a coat of layout fluid on the day it was installed to be tested in the coiler.

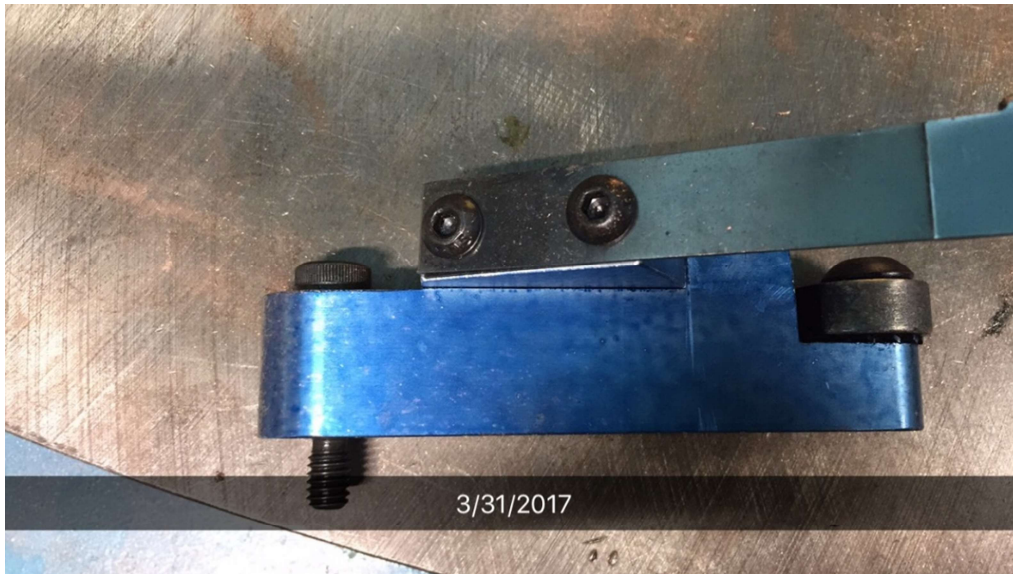
The layout fluid was applied on Thursday March, 23rd and installed into the coiler. The base plate that the finger sits on was also painted to see if the wire would hit that area now that we've removed the area of the finger that the wire was previously hitting. On March the 31st, the finger was removed from the coiler and both the part and the base plate were inspected for damage. No wire damage was observed on either part.

Figure 24. A view of the improved finger with no damage to the coat of layout fluid on the day it was removed from the coiler.
