D-Weld Sub-Assembly Leak Test Fixture

Final Report

Mechanical Engineering Technology

Tenneco Inc.

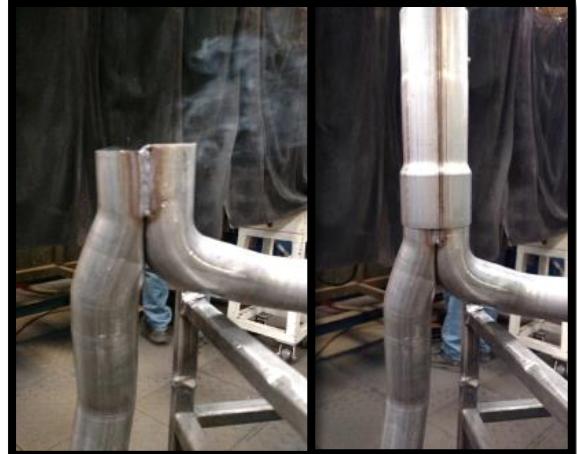
Figure 1: D-weld on the left, Cap pipe over D-weld on the right of exhaust y-pipe assembly.

The purpose of this project is to reduce the amount of scrap of complete exhaust Y-pipe assemblies due to linear leaks on the outlet D-weld. Once the cap pipe is welded over the D-weld (see Figure 1) the assembly is tested for leaks; the assembly fails the leak test if it leaks more than 4.5 square liters per minute. If the D-weld has a leak there is no way to repair it, because the cap pipe is already covering the welds, and the full assembly has to be scrapped.

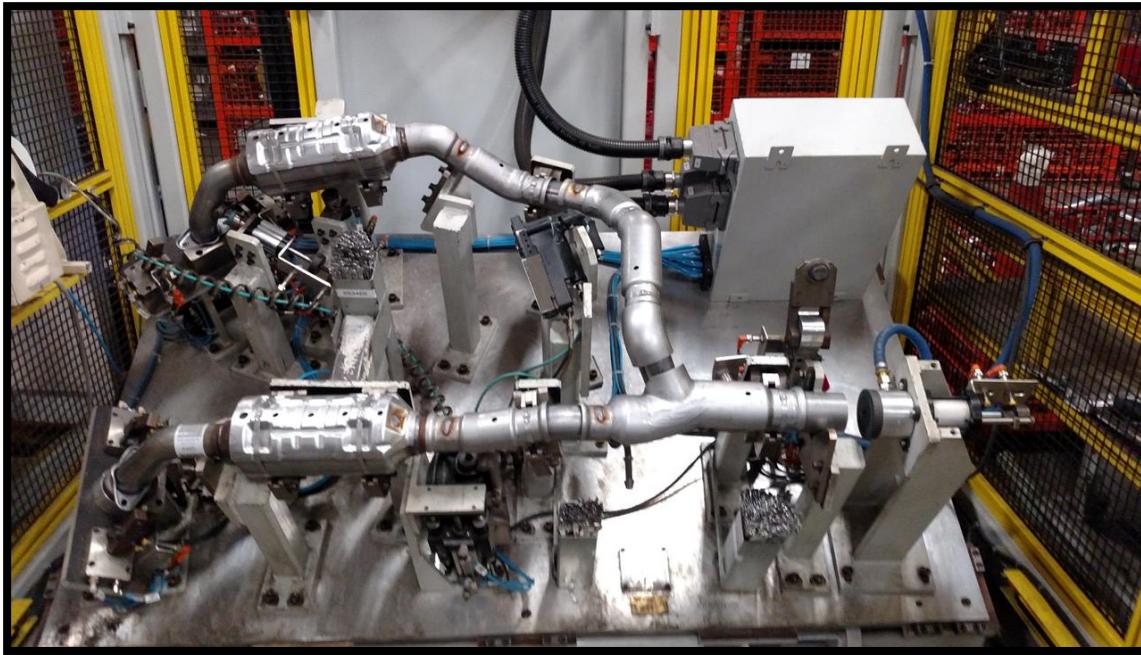
Figure 2: Current leak tester with full finalized assembly

Figure 2 shows a completed Y-pipe sub-assembly being leak tested. An initial performance baseline has been established after analyzing six month worth of the overall scrap data of this assembly. It has been concluded that linear and component burn through are the primary reasons for complete y-pipe assemblies.

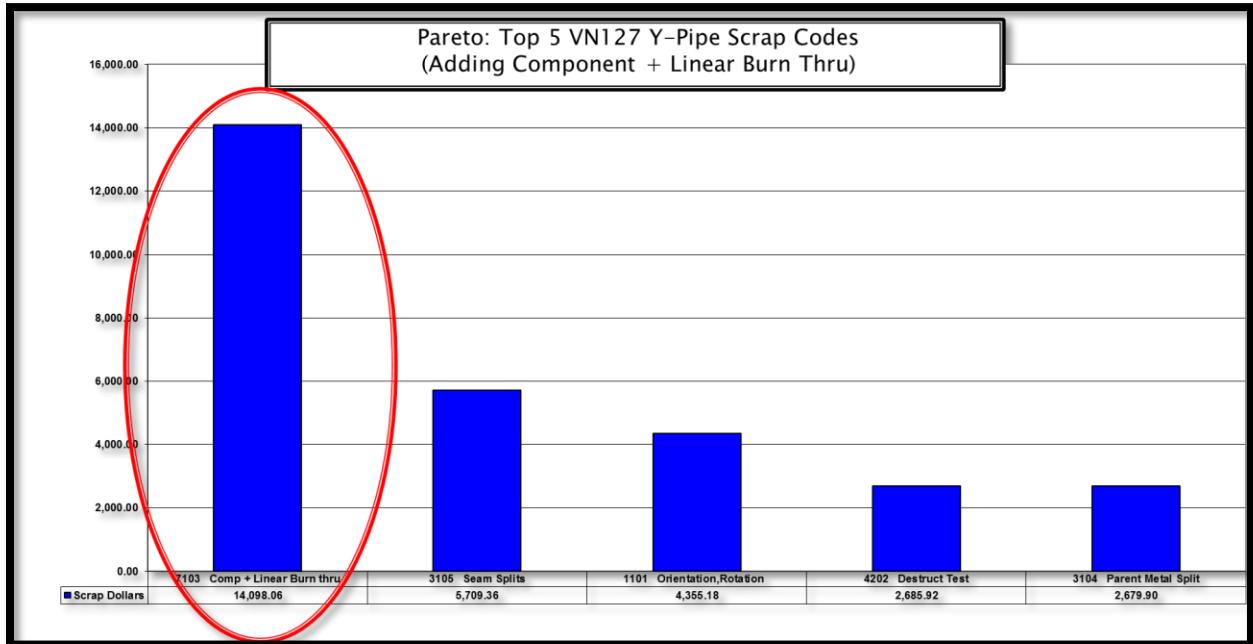
Figure 4: Pareto of top 5 producers of y-pipe scrap

Figure 3 and 4 show the data collected and the Pareto chart ranking the top five reasons of scrap of full y-pipe assemblies.

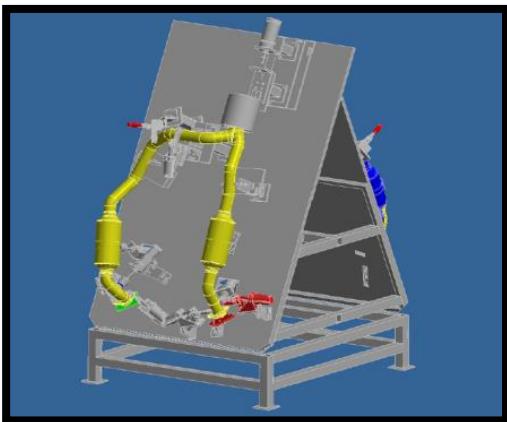
Figure 5: CAD model of Y-pipe before cap pipe being leak tested

The part will be loaded as depicted on the CAD model in Figure 5 to the left. The load can be treated as a non-uniform distributed load. The part weighs approximately 39 lbs. The material of the base plate is Aluminum which has a yield strength of 35 ksi.

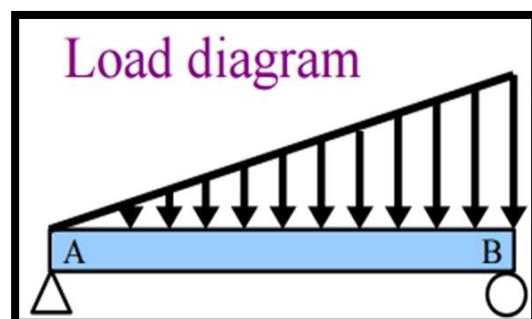
Figure 6: Non-uniform distributed load model.

Figures 6 and 7 show the load diagrams for a non-uniform distributed load and its equivalent single point load.

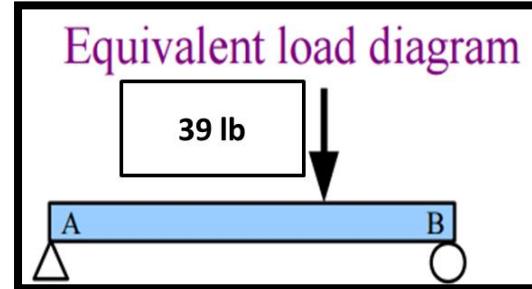
Figure 7: Equivalent load diagram of a non-uniform distributed load.

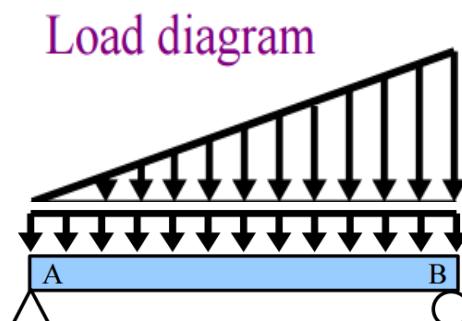
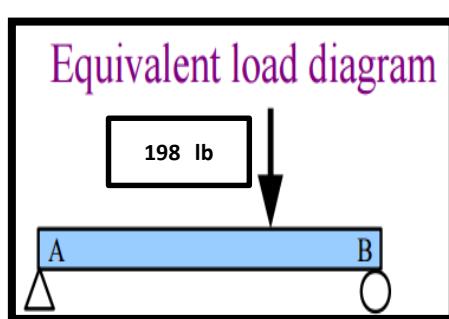
Figure 8: Load diagrams after adding the weight of the aluminum base plate.

Adding the weight of the 45" x 72" x 0.5" Aluminum plate, and knowing the density of aluminum (0.098 lb/in³):

$$\sigma = (39 \text{ lb} + 158.76) / ((45 \text{ in} \times 72 \text{ in})) = 0.061 \text{ psi}$$

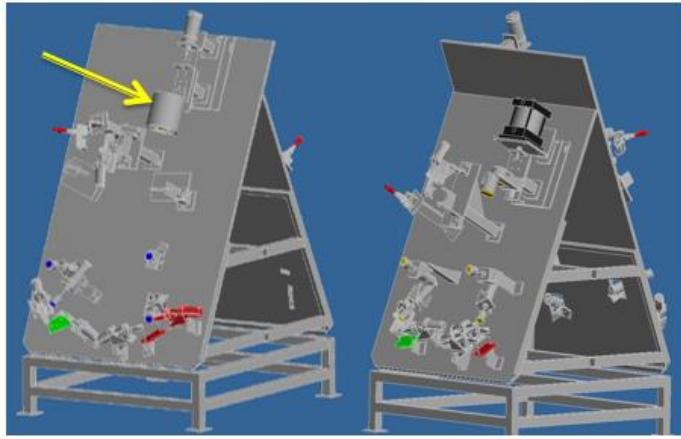
*Figure 10 *Right fixture is for the 4058 *Left Fixture is for the VN127 (main focus)*

Due to the limited space available in this department and the current flow of the part (VN127) it was decided to use a current leak tester for a different part number (4058) that runs through the same flow. In Figure 10 the black arrow represents the flow for all parts, the red arrow represents the flow for the VN127 (which is the main focus of this project), and the green line represents the flow for the 4058 Y-pipes. The blue circle signifies the leak test station that is going to be repurposed for this project.

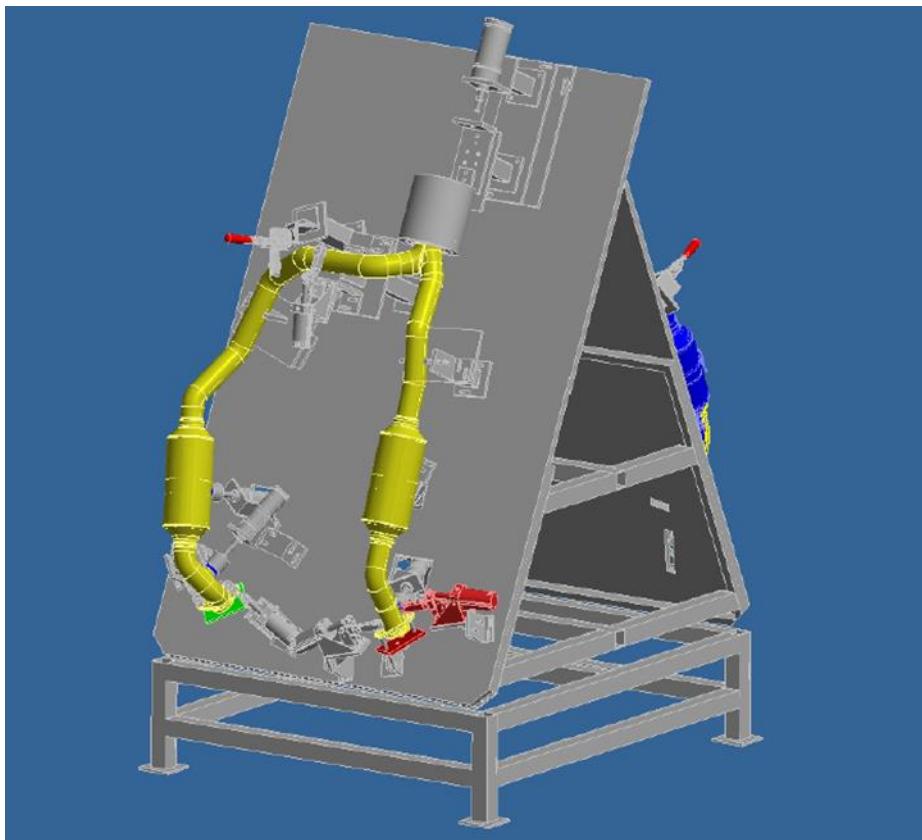
Figure 11 ISO view of leak tester with larger sub-assembly attached

The main focus is finding the leak on the D-weld on the VN127. To be able to securely seal this abnormal shape it has a 360 rubber seal that will go over the D-weld and shrink, this will create a tight seal over the D-weld portion. In Figure 11 the yellow arrow shows the location of this feature.

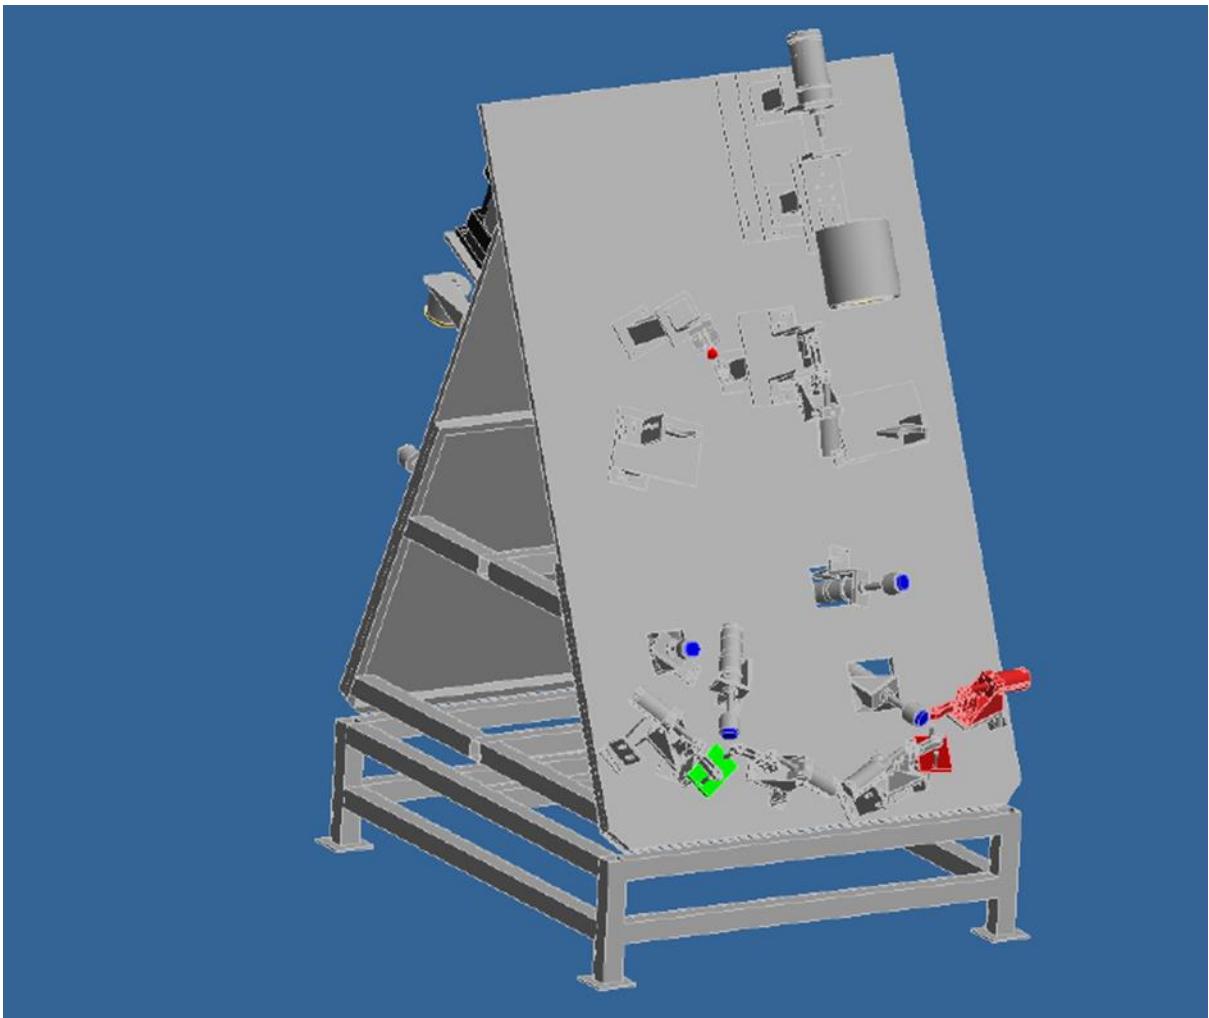
Figure 12 ISO view of same side as in Figure 1, without sub-assembly

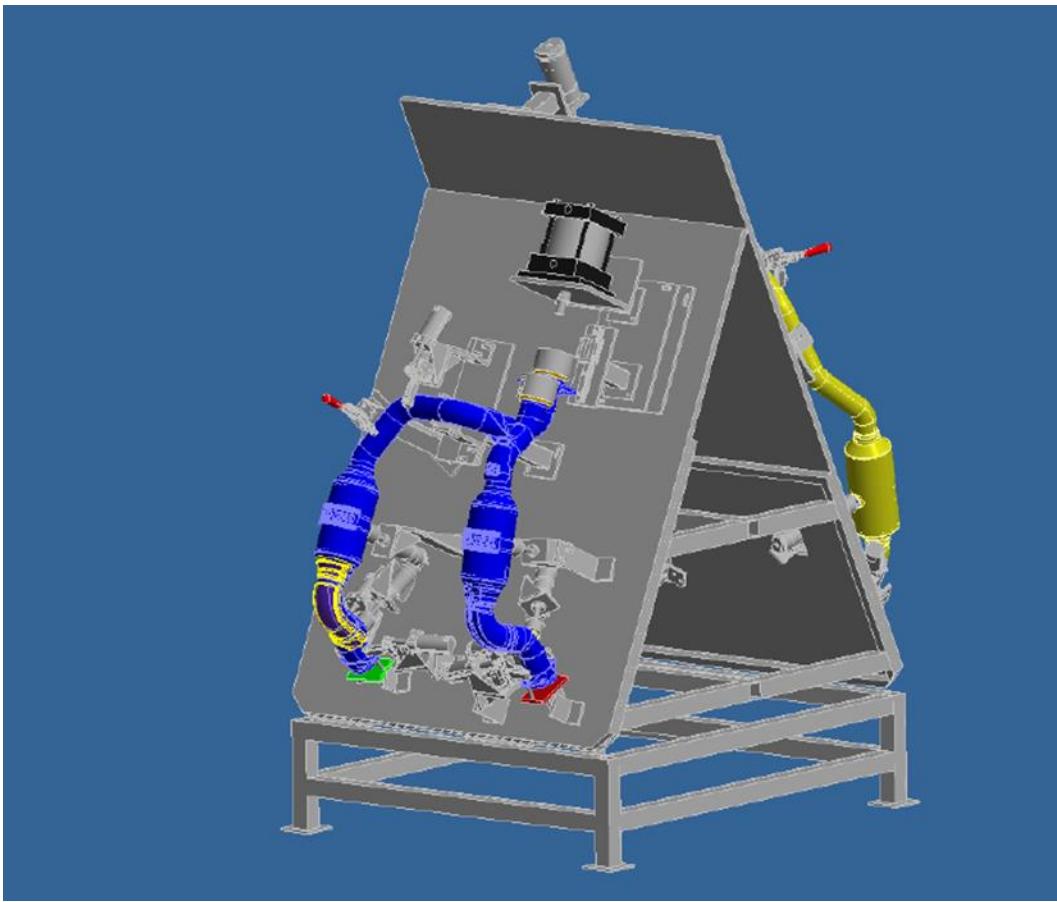
Figure 13 ISO view of back of leak test fixture, with smaller sub-assembly

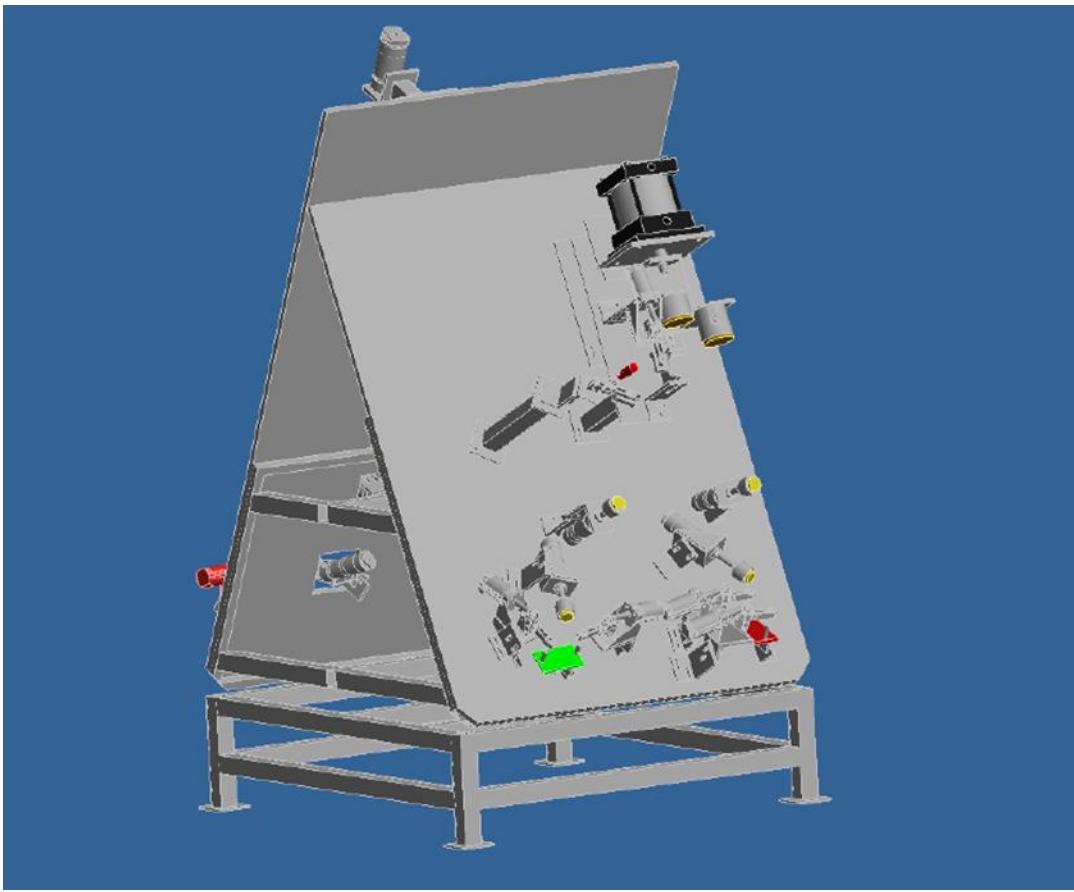
Figure 14 ISO view of same side as Figure 3, without sub-assembly

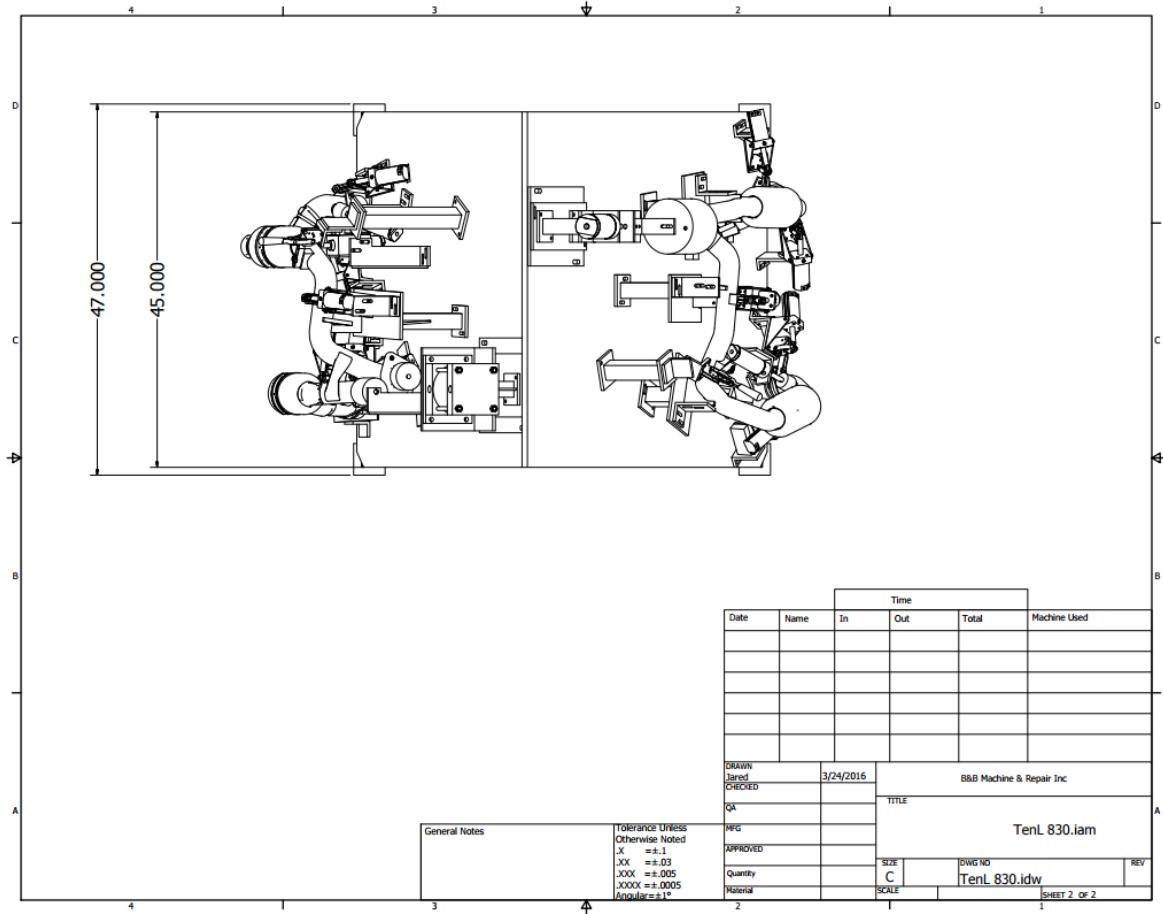
Figure 15 Overall width dimensions for the leak test fixture

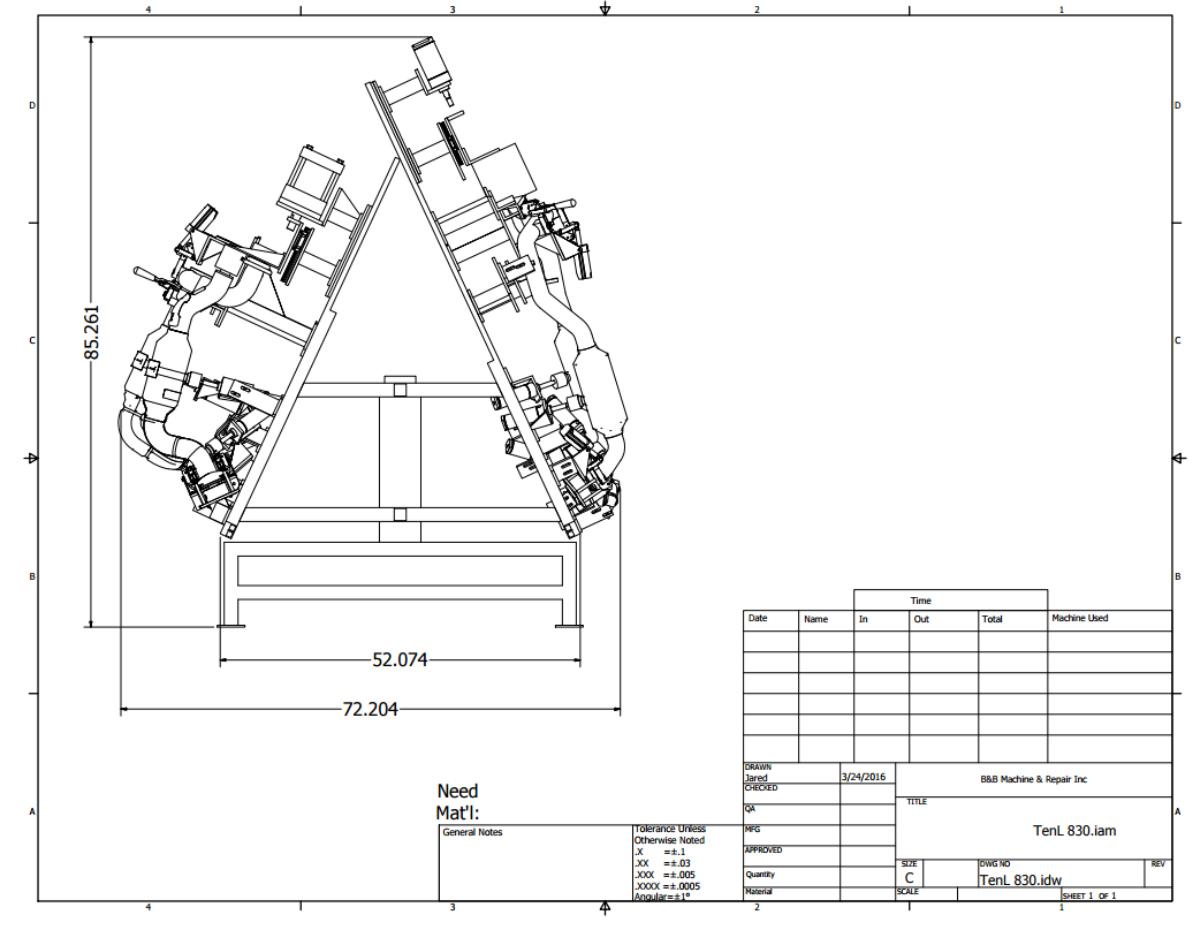
Figure 16 Overall height and depth dimensions of the leak test fixture
